# THE ENGINEERING GEOLOGY OF FRANKTON ARM.

A thesis  
submitted in partial fulfilment  
of the requirements for the degree  
of  
Master of Science in Engineering Geology  
in the  
University of Canterbury  
by  
**DEBORAH LOUISE STOSSEL**

University of Canterbury,  
June, 1999.

Seven bedrock landslides situated within quartzofeldspathic schist exist up slope of the residential area along the Frankton Arm of Lake Wakatipu, South Island, New Zealand. Engineering geological and geotechnical failure models for these landslides have been established using engineering geological mapping at scales of 1:5000 and 1:10000, geotechnical testing, and the development of limit-equilibrium sensitivity models.

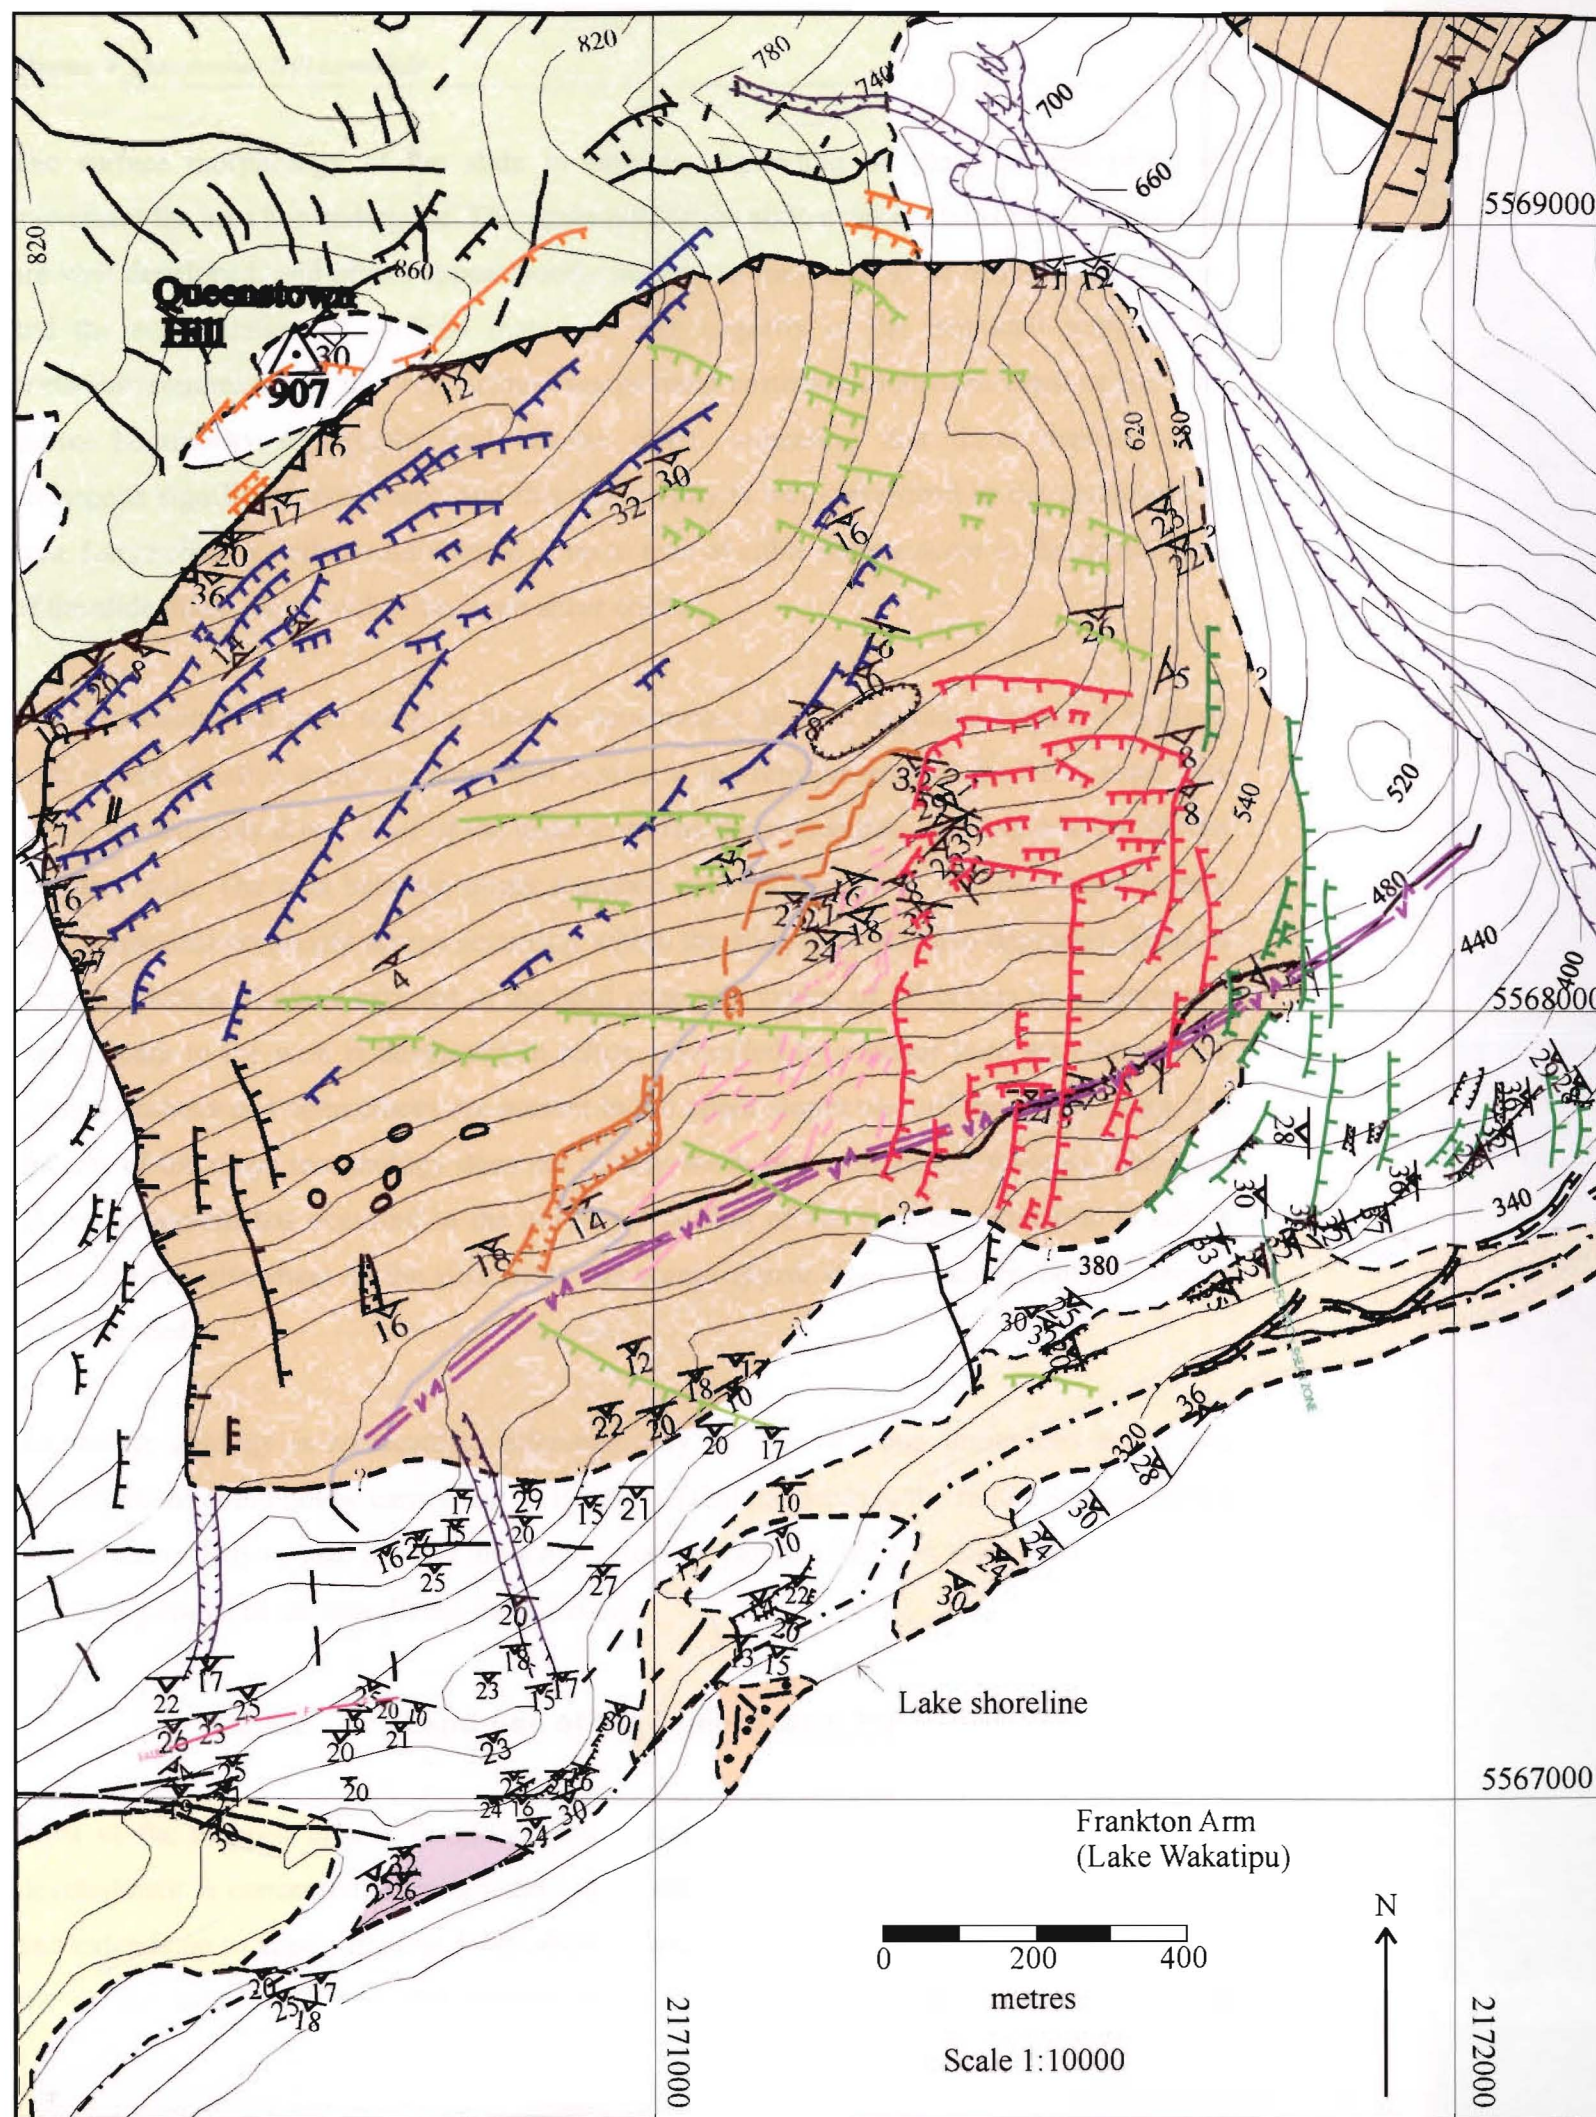
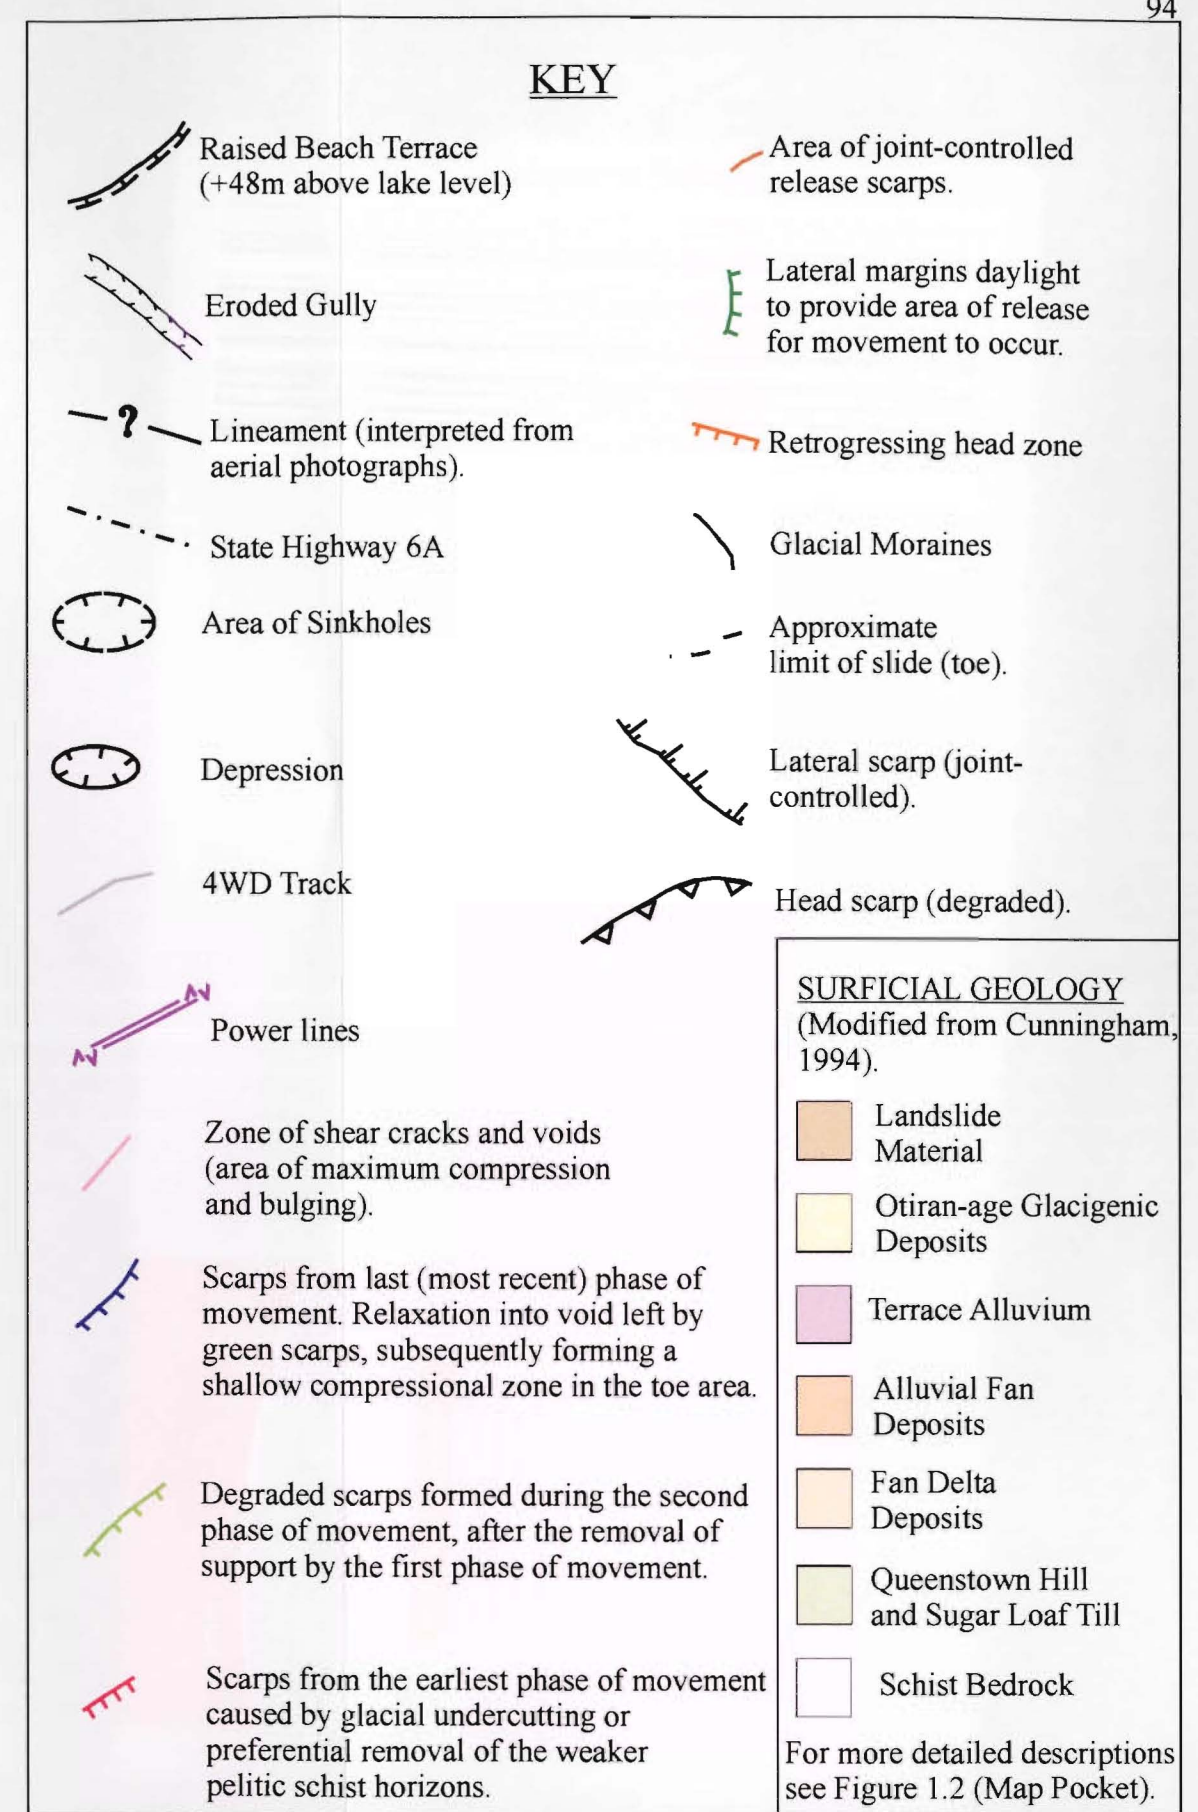
Figure 4.4: 1:10000 geomorphological map of the Queenstown Hill Landslide.

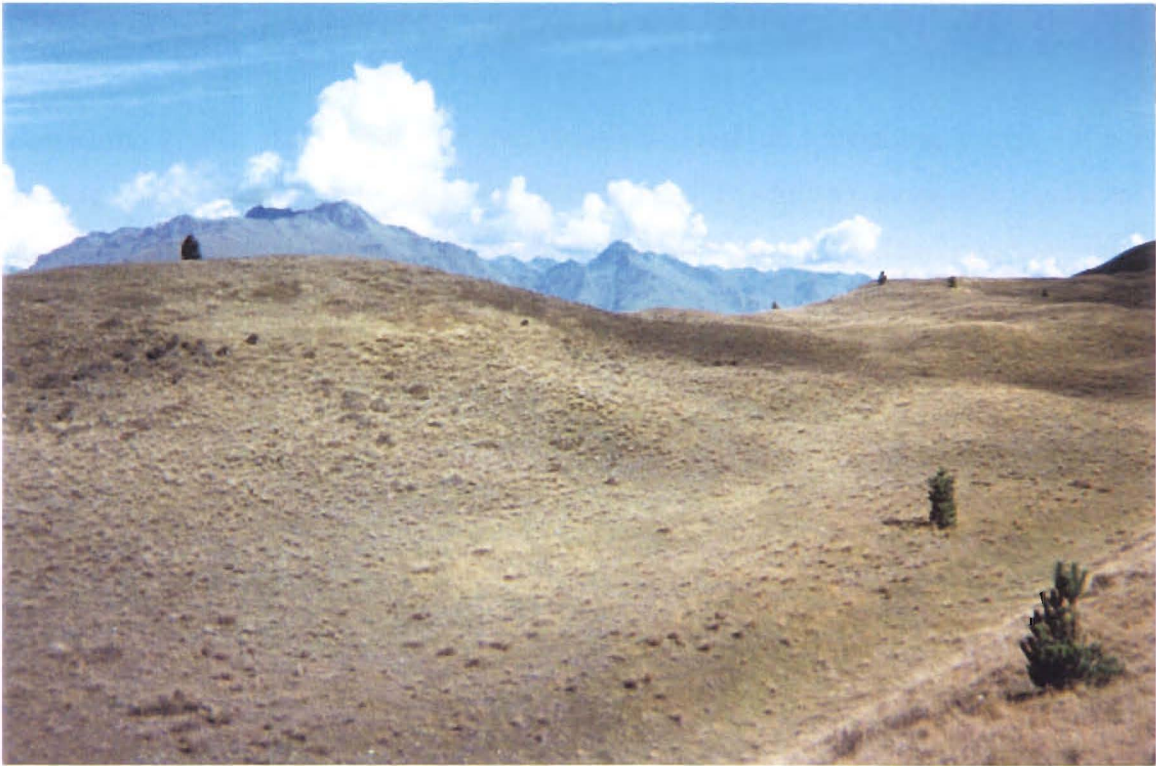
Figure 4.5: The Queenstown Hill Landslide degraded head scarp, showing the graben running parallel to the head scarp.

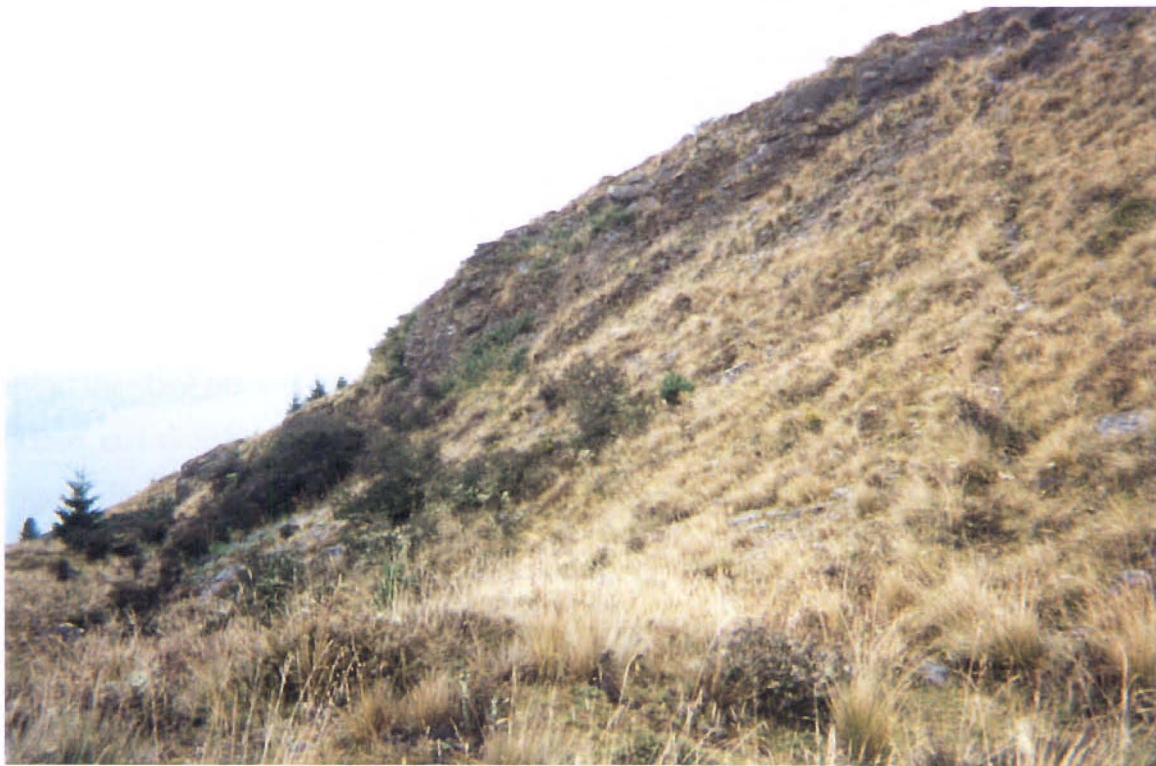
Figure 4.6: The prominent western lateral scarp of the Queenstown Hill Landslide. Photo taken looking west.

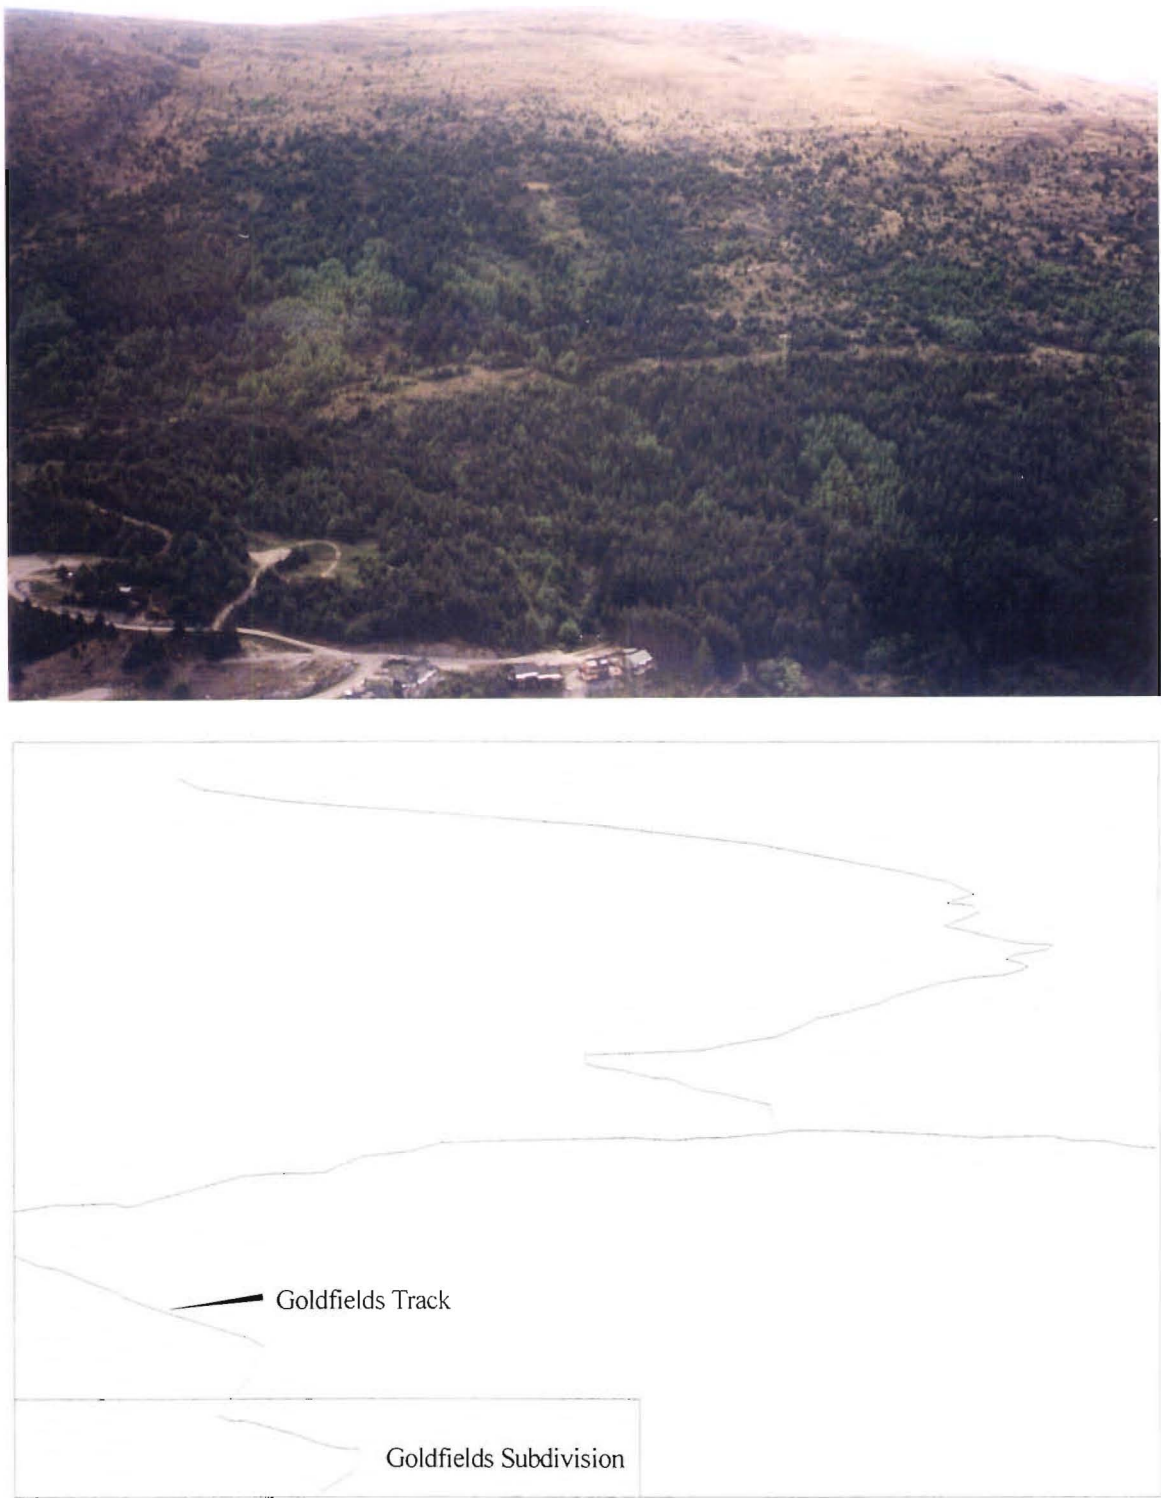
Figure 4.7: Queenstown Hill Landslide, showing Goldfields Subdivision in relation to the landslide area, and the 4WD track to the summit. Note the prominent lateral scarp to the left (west) and the concentration of vegetation on the lower slopes. The head scarp is at the skyline.

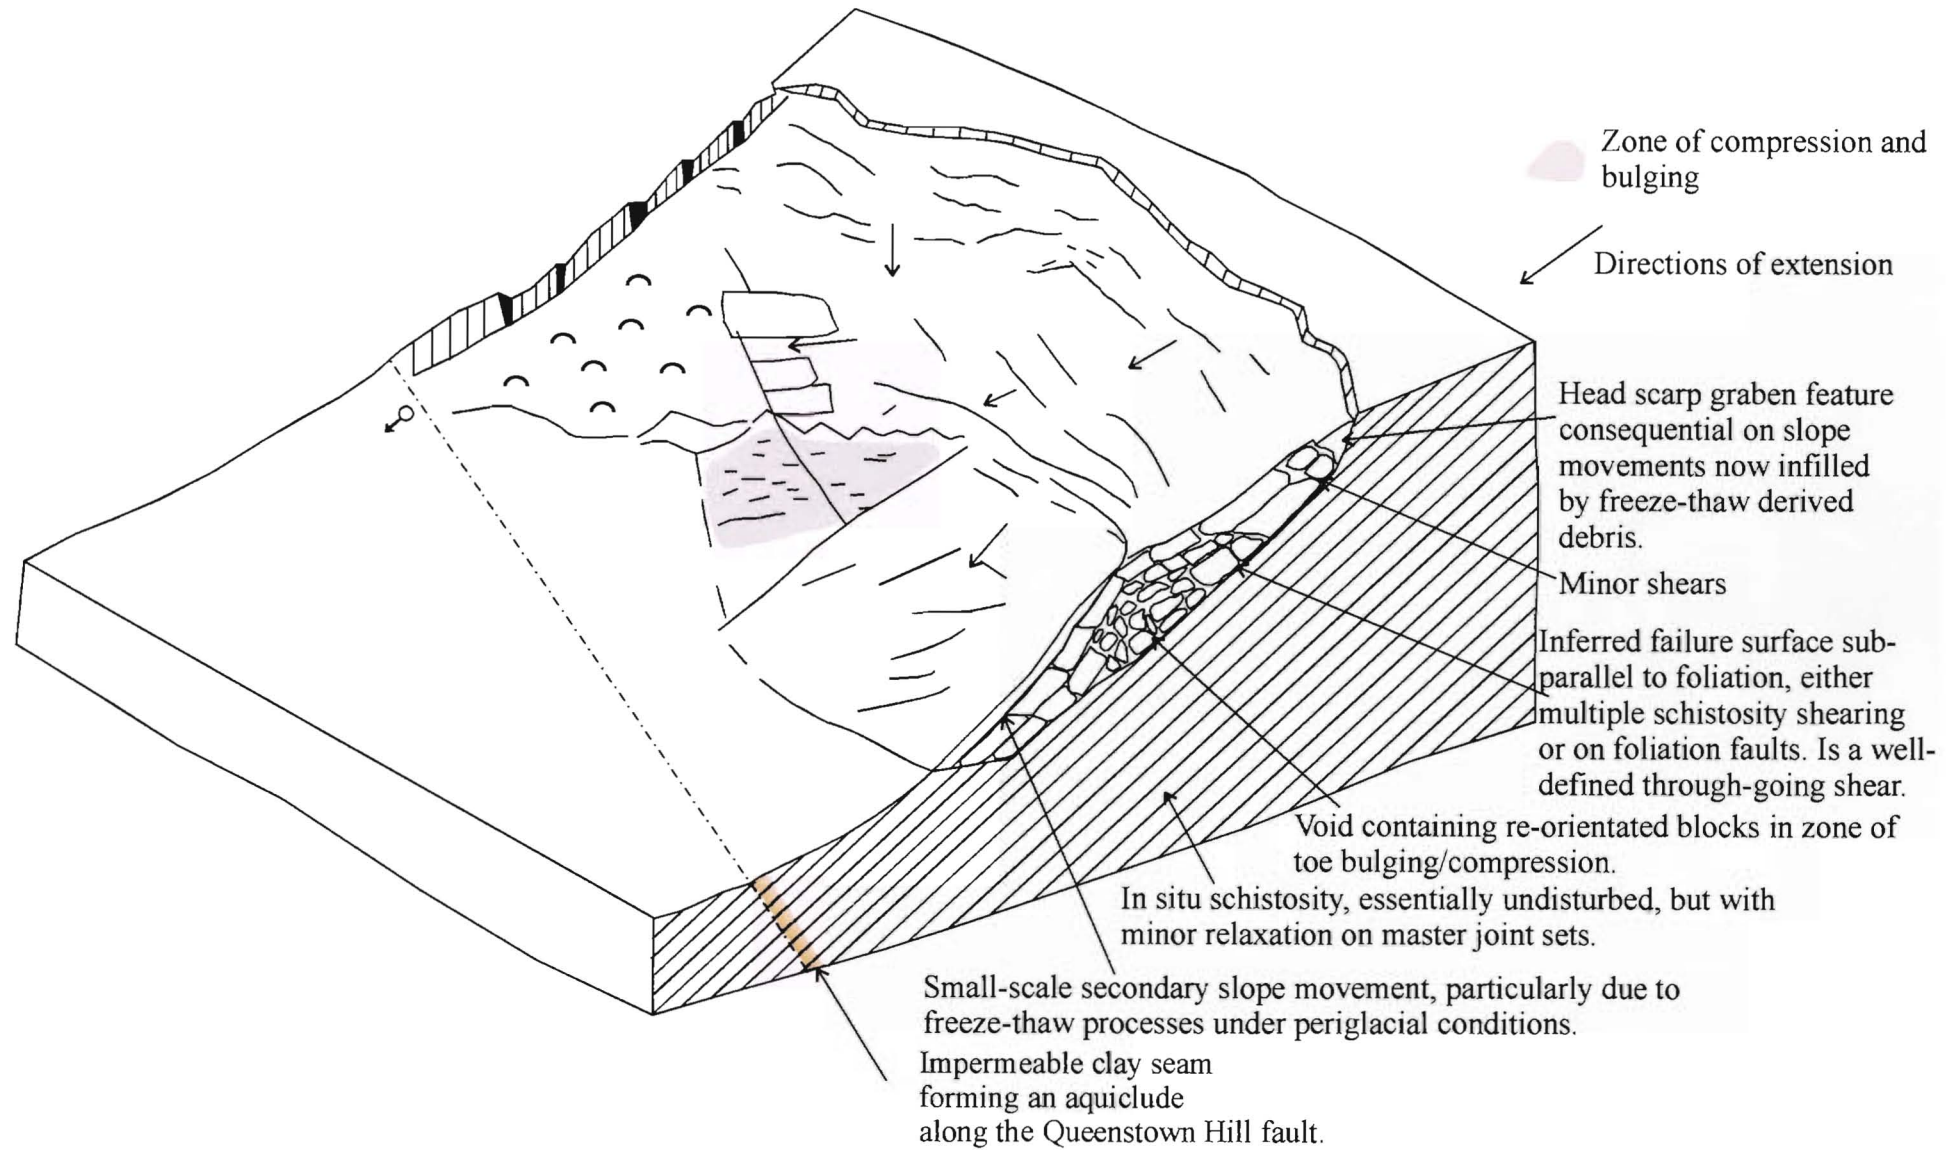
Figure 4.8: Schematic block diagram of the Queenstown Hill Landslide preferred toe compression model.

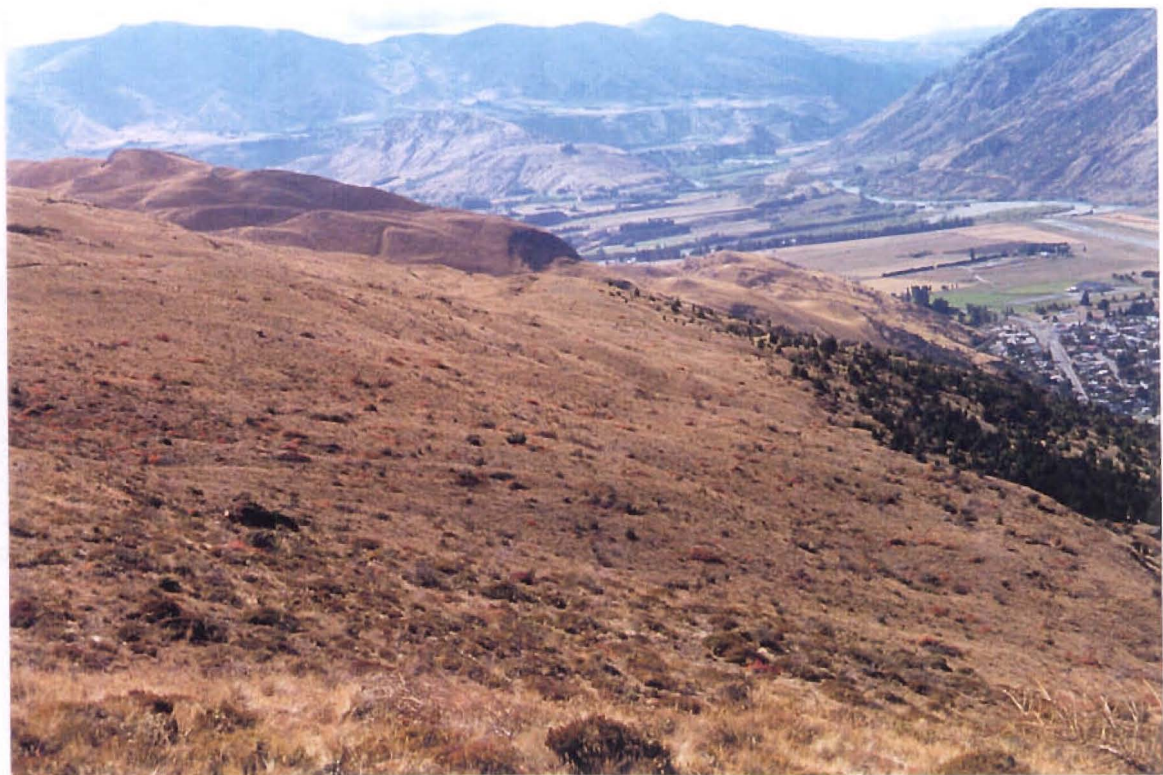
Figure 4.10: Hummocky topography of the Queenstown Hill Landslide, taken from the western lateral scarp looking east. The Crown Terrace is in the distance, with the Shotover River flowing at the base of The Remarkables.

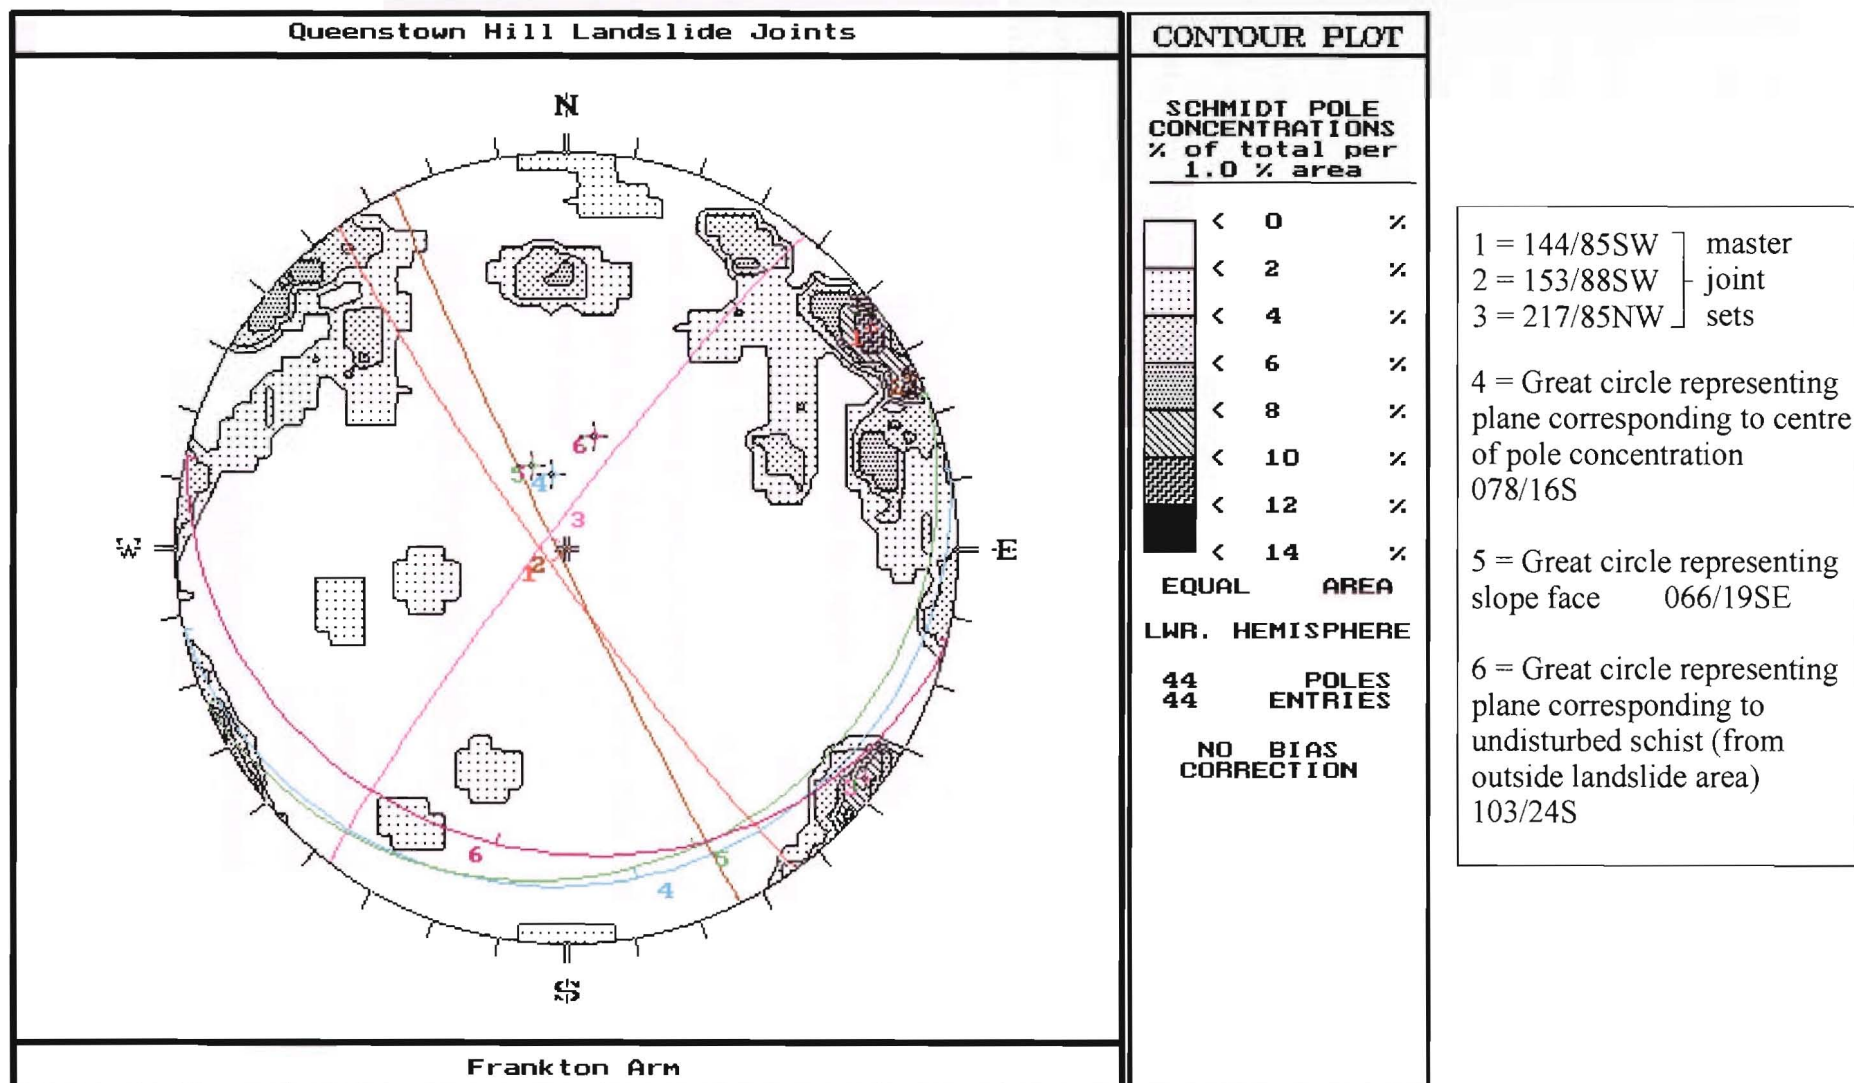
Figure 4.11: Queenstown Hill data showing the master joint sets and major structural features.

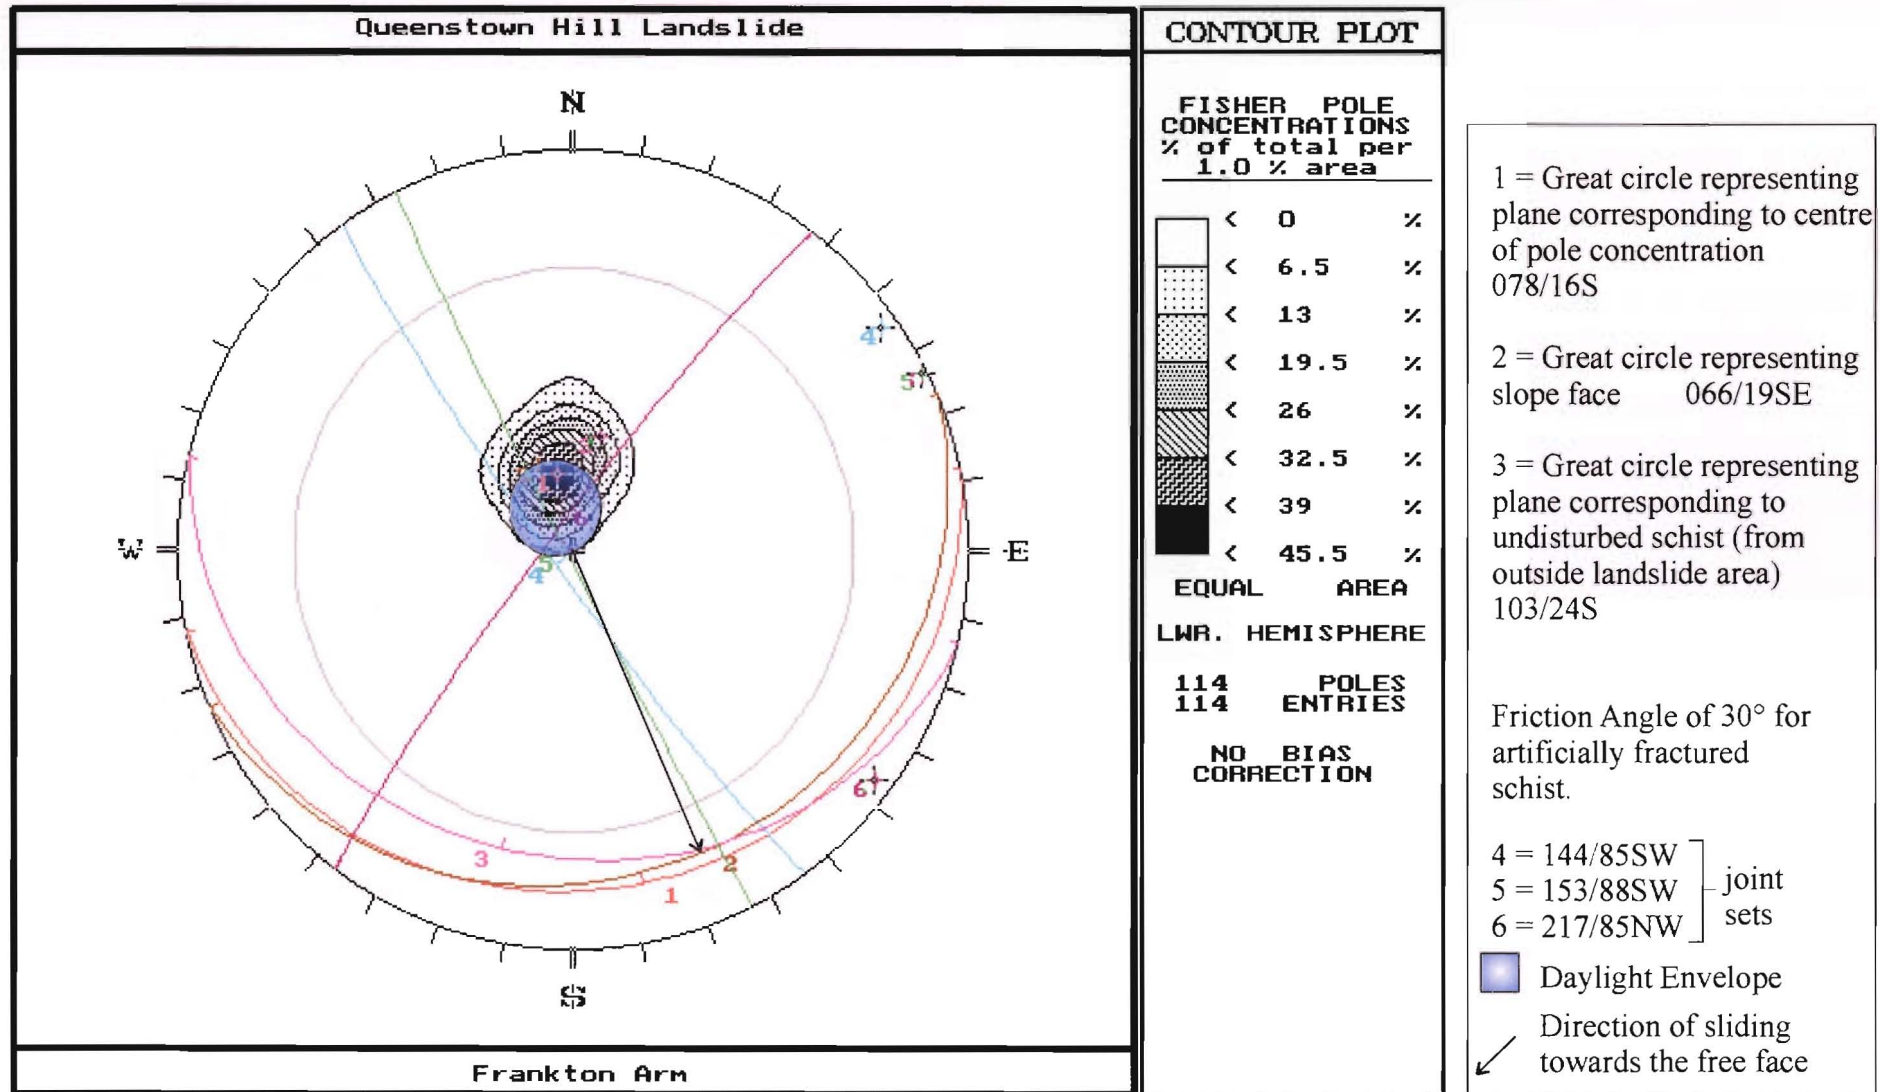
Figure 4.12: Stereonet showing major structural controls of the Queenstown Hill Landslide, using a friction angle of 30°, a value obtained from laboratory testing of artificially fractured schist collected from outside the slide area. There is no Markland's zone of instability formed.

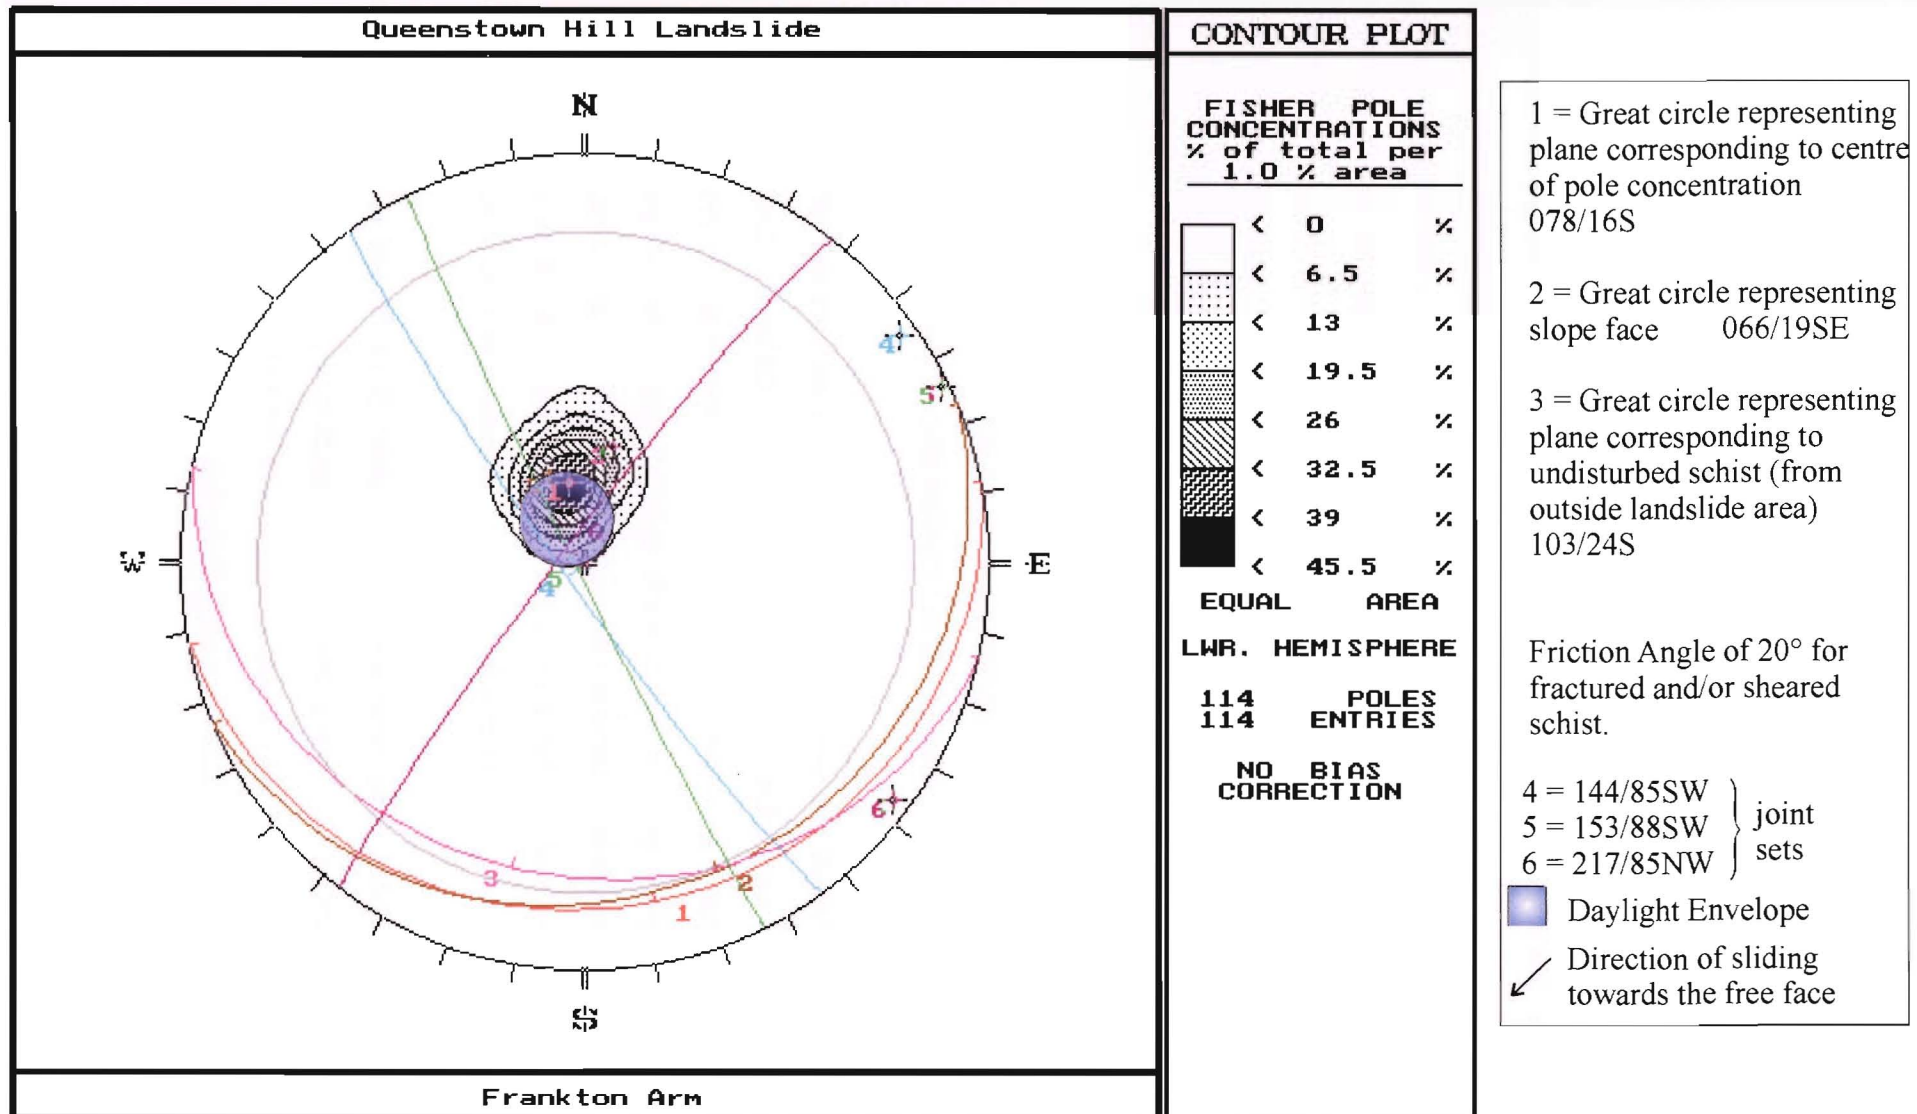
Figure 4.13: Stereonet showing major structural controls of the Queenstown Hill Landslide, using a friction angle of 20°, a value assumed for foliation shear zone material collected from outside the slide area.

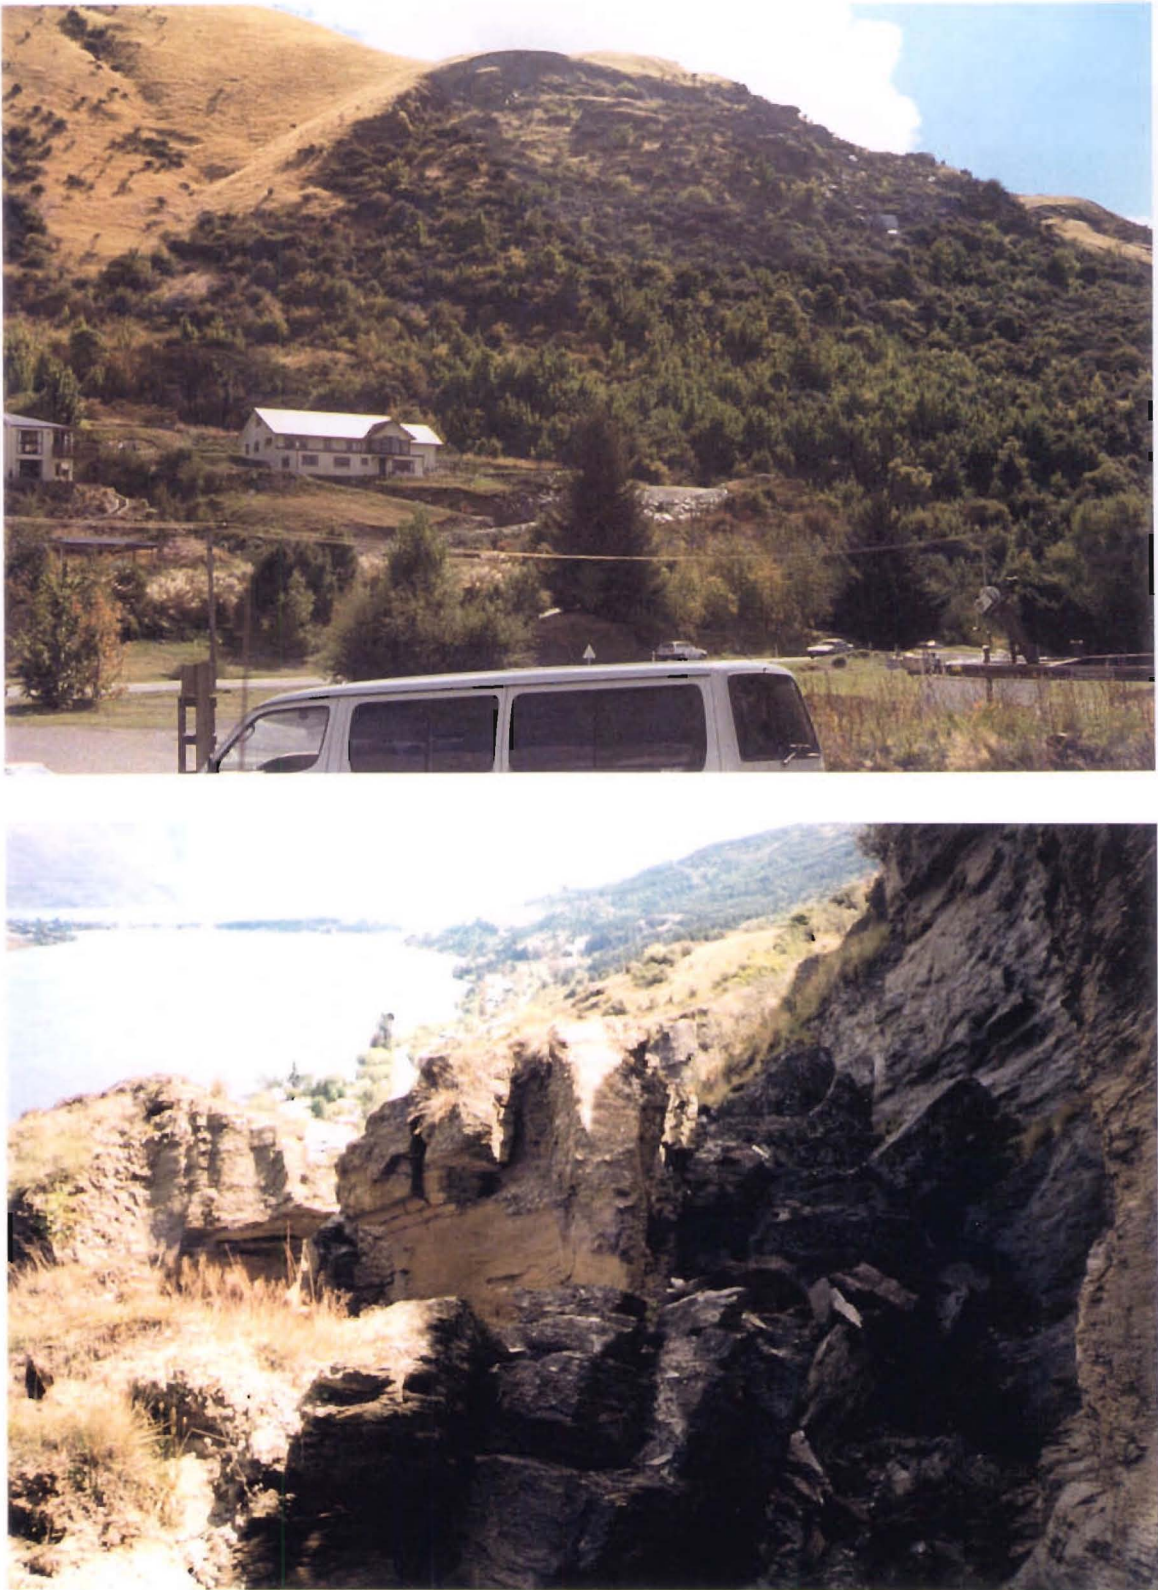
Figure 5.2: Slide No. 3 (top) and Slide No. 4 (bottom) showing the large wedge failures coming from the head scarps. Marina Heights Extension subdivision is shown in the middle left of the top photo.

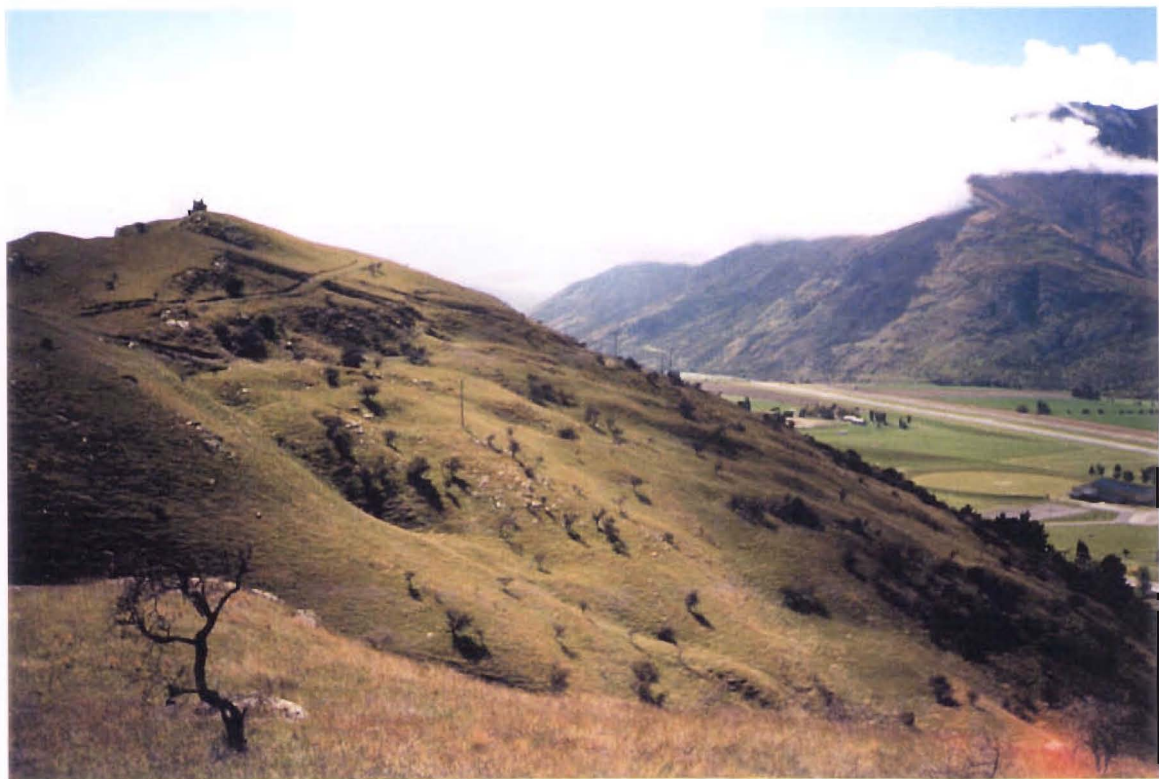
Figure 5.3: Photo looking east over Slide No. 5 with The Remarkables in the distance. This failure shows hummocky topography and a retrogressive head scarp.

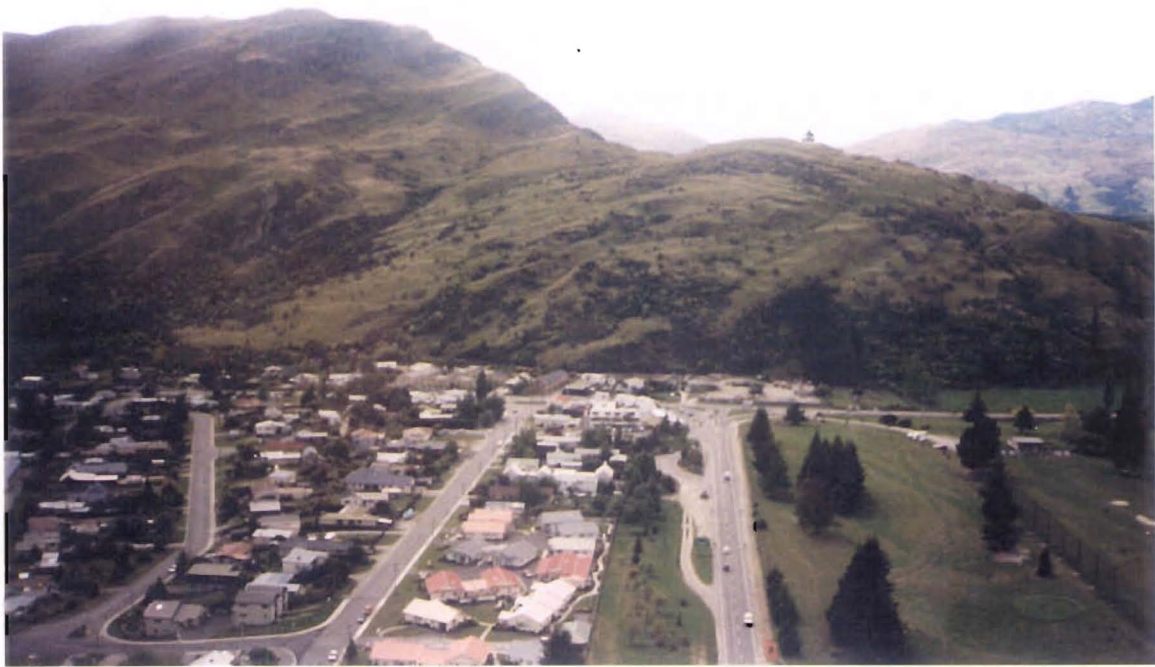
Figure 5.4: Photo showing Slide No.'s 5 and 6 taken facing north. Note variable degradation between the scarps within the slide masses.

The state of activity for most of the slides along Frankton Arm can be classed as relict, as they developed under different climatic conditions. Vegetation has become established on the main head scarps of Marina Heights, Slide No. 5 and No. 6 (figure 5.4), thus the slides can be classed as dormant. Drainage extends across Slide No. 2 without obvious offset, thus is considered to be relict. Slide No.'s 3 and 4 would be classed as inactive as they show minor movement and retrogression within the head scarp areas. This type of movement is inferred to be a continual process, with small wedges collapsing off the head scarps on to the slopes immediately below. The distribution of activity is retrogressive in all cases as the failure surface extends in the direction opposite to the movement of the displaced material. Several minor retrogressive scarps exist up slope of the main head scarps of the slides which are

The land making up the slide is used for sheep grazing. No residential development occurs on the slide, although on the flat land immediately south of the irrigation canal, houses have been built adjacent to the main highway (figure 5.4). These houses are not considered to be at risk from any movement of this landslide.
